Integrating the New with the Old: Transformations of the Değirmenbaşı Street in the City of Safranbolu in Türkiye

It employs a case study approach looking into one of the streets: the Değirmenbaşı Street. Data is collected through on-site observations, photographic documentation, and archival research. The paper reveals the different façade characteristics of the old and the new houses of Değirmenbaşı Street and to what extend they either integrate with each other or not. Thus, it maps out the extent to which the character of the city has changed. It concludes that the constructions in the Bağlar district are not harmonious to each other except their building order, floor number, and maximum height. The re-constructed houses have led to the degeneration of the city. It argues that the historical environments should be conserved, adapting to the existing conditions and henceforth. This requires that planning authorities must recognize the importance of the past of the city for establishing its urban identity.

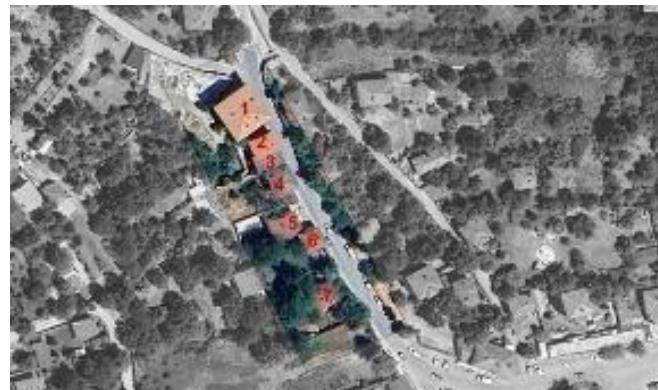
Fig. 4: Layout of Değirmenbaşı Street.

On both sides of the street, traditional houses are situated. One side features large cultural landscape gardens and a few registered heritage buildings, while the other side includes a higher density of housing, comprising both historic and newly constructed structures. The coexistence of old and new buildings, and the visible contrast between authenticity and transformation, make this section particularly suitable as a representative study area for analyzing the interactions between the traditional and contemporary architectural layers of Safranbolu (Fig 4).

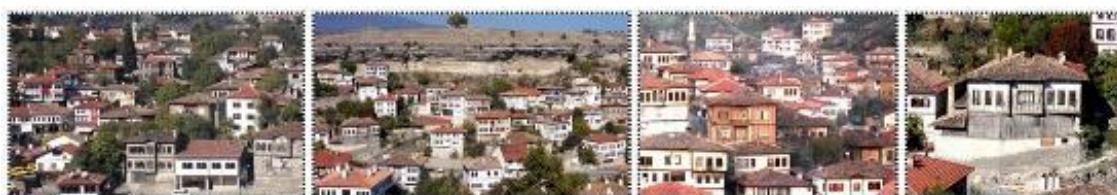
Fig. 5: Traditional Safranbolu houses.

In fact, they all come together to form an incomparable architectural aesthetics (Fig. 5). The ground floors of the houses, which are made of stone, form at the same time, the basis of the buildings. They are generally windowless. The other floors consist of half-timber frames. The middle floor has a low ceiling. In this floor, there is a kitchen. The daily life usually passes at the mid-floor. The top floor has a great number of windows and its façades are go-go because of the bay windows. The ceiling here is higher and the rooms are used as the bedrooms.

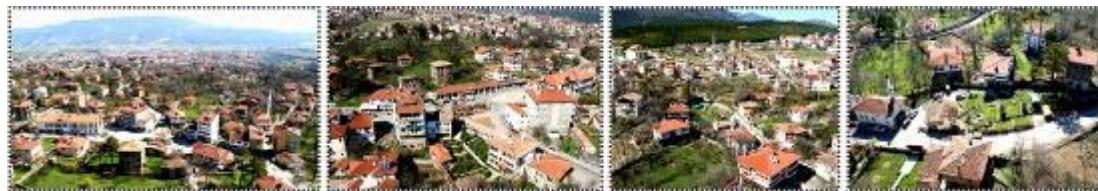
Fig. 6: The Bağlar district.

city. In fact, there are always many surprises. Nevertheless, in reality, the total distance is only 1500 m. (Günay, 1999). Today, the Bağlar district, blended with green, wood, and stone, demonstrates the new constructions in addition to its old houses. Therefore, its identity has partly changed (Fig. 6).

The Bağlar district is situated in the North-West of the winter district on a gentle slope facing the South. The houses are within large gardens, and they have an infrequent settlement pattern. The topography here is not as interesting as in the Çarşı district. However, the roads winding among the gardens give the impression that you are walking in a very large part of the

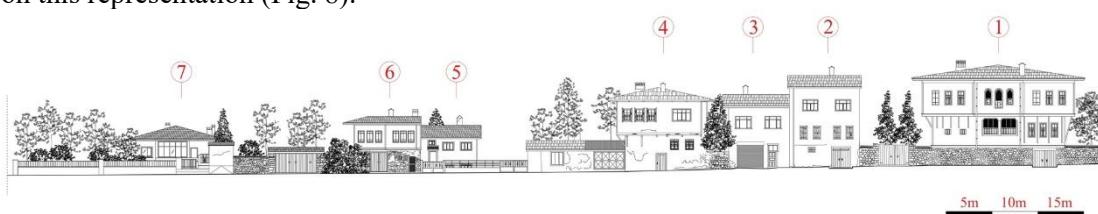
Fig. 8: Silhouette of Değirmenbaşı Street.

Within the traditional settlement fabric of Değirmenbaşı Street, the historic building walls, entrance doors, bay windows (oriel), garden walls, trees, and traditional water channels running along the street line collectively constitute the defining elements of the streetscape. However, it has been determined that certain changes in the recent developments have weakened this overall integrity. In order to illustrate the coexistence of the old and new structures, a street silhouette drawing was prepared as part of the study, showing the buildings and their surrounding components together, and interpretative analyses were carried out based on this representation (Fig. 8).

The Bağlar district has also gained its identity through the presence of large gardens historically used for agricultural production. Today, however, most of these productive activities have largely disappeared. On both sides of the street, vegetation is prominent, and trees are densely distributed (Fig. 12). In contrast, the garden of house No. 5, a later construction, has a higher proportion of paved surfaces and fewer trees compared to the surrounding environment. In the street silhouette, this discontinuity is evident where the continuity of green texture is interrupted by this particular house (Fig. 8).

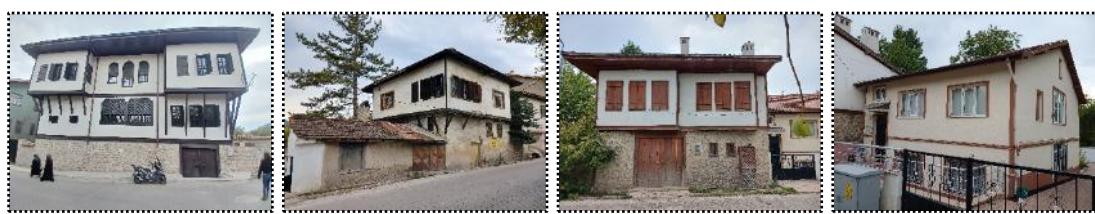
Fig. 9: Old houses with bay windows (projections) and a new house without a bay window (right)

In contrast, the later-built House No. 5 lacks a street-facing bay window (Fig. 9). The absence of this volumetric articulation - commonly found in traditional façades - has resulted in a divergent architectural language and has weakened the sense of unity within the streetscape. In contrast, House No. 7 features a bay window on its entrance (upper) floor, designed in imitation of traditional architecture, thereby referencing historical forms while lacking the structural and contextual authenticity of the originals.

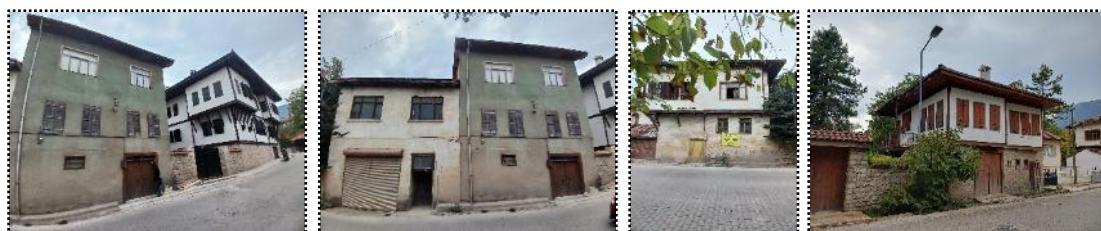
Fig. 10: Use of wooden materials in historic houses along the street.
Source: Author Fidan, 2025.

The doors and windows of the older houses (Nos. 1, 2, 3, 4, and 6) along the studied street are made of wood (Fig. 10). The entrance gates of their gardens are also constructed from wood. The windows feature wooden shutters designed as protection against the climatic conditions. However, in the later-built houses (Nos. 5 and 7), steel doors and PVC windows have been used instead (Fig. 11). These material differences have weakened the continuity of local material use that characterizes the traditional streetscape.

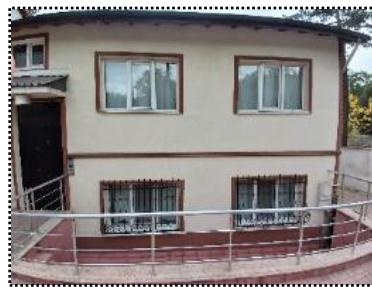
Fig. 13: The sunken area created in front of the lower floor of house No. 5.

Traditional houses in Safranbolu have been designed in harmony with the natural topography, developing solutions that respect the surrounding environment. In areas with steeper slopes, multiple-level entrances were often created by taking advantage of the terrain. However, in the analyzed area, the later-built house No. 5 does not adapt to the topography, unlike the traditional houses. On its front façade, a sunken area has been created to allow light into the lower floor, which lies below the street level (Fig. 13). Instead of green landscaping, this open space is covered with hard surfaces, resulting in weak spatial use and limited integration with its context.

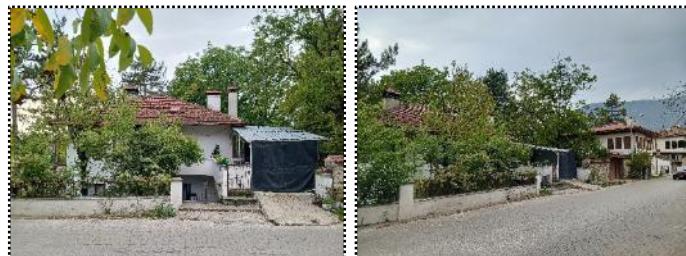
Fig. 14: The incompatibility of the semi-open addition in front of House No. 7 with the surrounding context.

One of the main factors disrupting the overall street silhouette is the construction of low-quality add-on spaces and the lack of coherence in material language used in new additions. The semi-open space later added to the entrance level of House No. 7 fails to establish any design unity with the adjacent building. Its roof covering is made of corrugated metal sheets, the entrance is enclosed with PVC tarpaulin, and its structural columns are made of iron. These poorly executed and deteriorated materials appear inconsistent both among themselves and with the refined architectural character of the surrounding context (Fig. 14). In front of the House No. 5, a white wall separates the open area from the street, topped with gray aluminum railings and balustrades, while the two gates providing access from the street are made of black iron. The gates emphasize vertical divisions, whereas the railings emphasize horizontal lines. This contrast in color and design language among small-scale architectural elements again leads to visual disharmony (Fig. 15). Furthermore, the roof of the storage/garage structure adjacent to the registered House No. 4 also shows a mix of materials — one half is covered with clay tiles, while the other half uses corrugated metal sheets (Fig. 15). However, corrosion has developed on the metal sheet surface, causing the material to lose its original properties, further degrading the visual integrity of the structure and its surroundings.

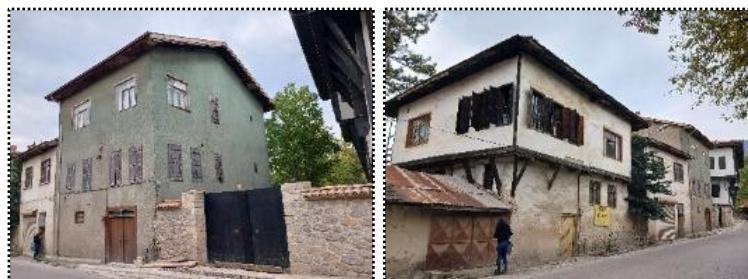
Fig. 16: Different window applications in Houses No. 2 and No. 4.

The window alterations in House Nos. 2 and 4 (registered) within the study area have partially compromised their originality (Fig. 16). In the House No. 2, the intermediate floor displays a rhythmic window arrangement with a 1/2 proportional system, which is notably absent on the upper floor. Similarly, in the registered House No. 4, beside the original upper-

floor windows, there are later replacements featuring different proportions and colors. These inconsistencies disrupt not only the overall harmony of the historical fabric but also the visual composition of the individual building façades.

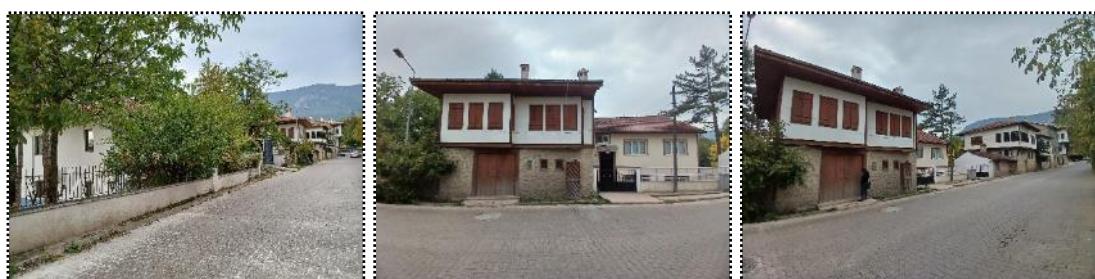
Fig. 17: The coexistence of old and new buildings along the street.

Another aspect of harmony lies in the mass forms of the buildings. The older houses generally exhibit rectangular façades and articulated massing. Their pitched roofs have been designed to adapt to climatic conditions, and their wide eaves provide additional protection. While the registered House Nos. 1, 4, and 6 feature hipped roofs, the House Nos. 2 and 3 have gable roofs (Fig. 8). These volumetric configurations contribute not only to functional performance but also to aesthetic coherence. Similarly, the later-built House Nos. 5 and 7 adopt rectangular forms and gable roofs, consistent with the surrounding fabric. However, the absence of volumetric articulation on the street façade of House No. 5 weakens this visual harmony. When viewed as a whole, the building heights across the street remain within a human scale. While House Nos. 1 and 2 have three stories, the others are two stories high. The mass and heights of Houses No. 5 and 7 are kept respectful to the adjacent registered buildings (Fig. 17). Their roof ridge heights are positioned below the maximum heights of the neighboring structures, and their horizontal mass proportions are also restrained, ensuring compatibility with the scale of the historic environment.
